Warkworth Castle, Northumberland (England)

Report on two geophysical surveys (2020, 2021) funded by the
Castle Studies Trust - 30 June 2021

By Mark Douglas¹, Duncan Hale², William Wyeth¹

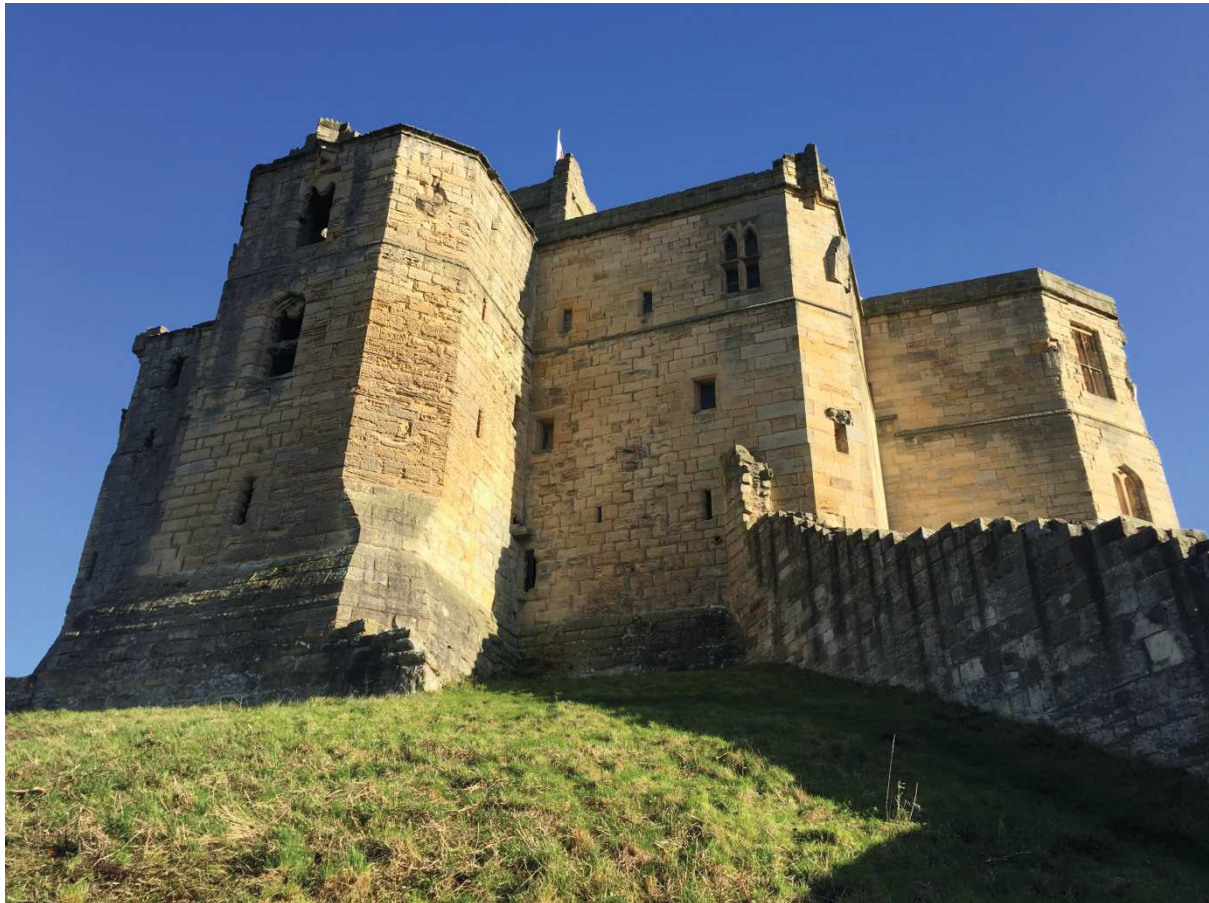
Figure 1. Photograph of the Great Tower at Warkworth Castle, built late 14th century. View looking east from the western base of the motte, outside the embrace of the curtain wall. © William Wyeth

Though the highlight of Warkworth is undoubtedly its late medieval Great Tower (Figure 1), it has too often overshadowed what remains an equally impressive and largely under-appreciated earlier residence from the golden age of castles as well as a rich and diverse landscape, which have hitherto not featured prominently in the canon of high-status complexes of similar stature and material extent.

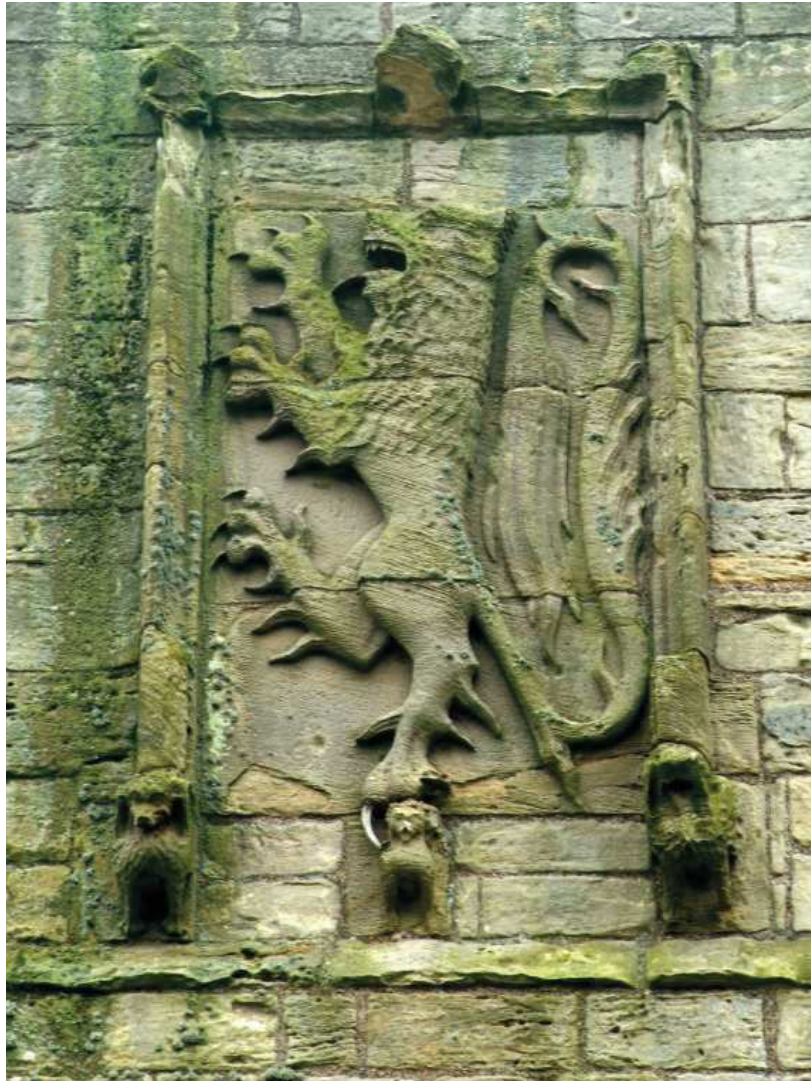
Figure 2. Photograph of Percy lion relief sculpture on N face of Great Tower. At least one claw is composed of metallic material or finish. © Historic England Archive

In a more general sense, the castle sits within an impressive medieval (loosely defined) landscape. The Great Tower, though later in date, also references a clear castle-settlement relationship in its presentation, on the townward face of the tower, of a storey-high Percy lion relief (Figure 2). The planned settlement, comprising an axial road from the castle at the base of the loop in the River Coquet, to the parish church and medieval fortified bridge at the curve of the river, is an essential piece of evidence in understanding the castle's early development (Figure 3).

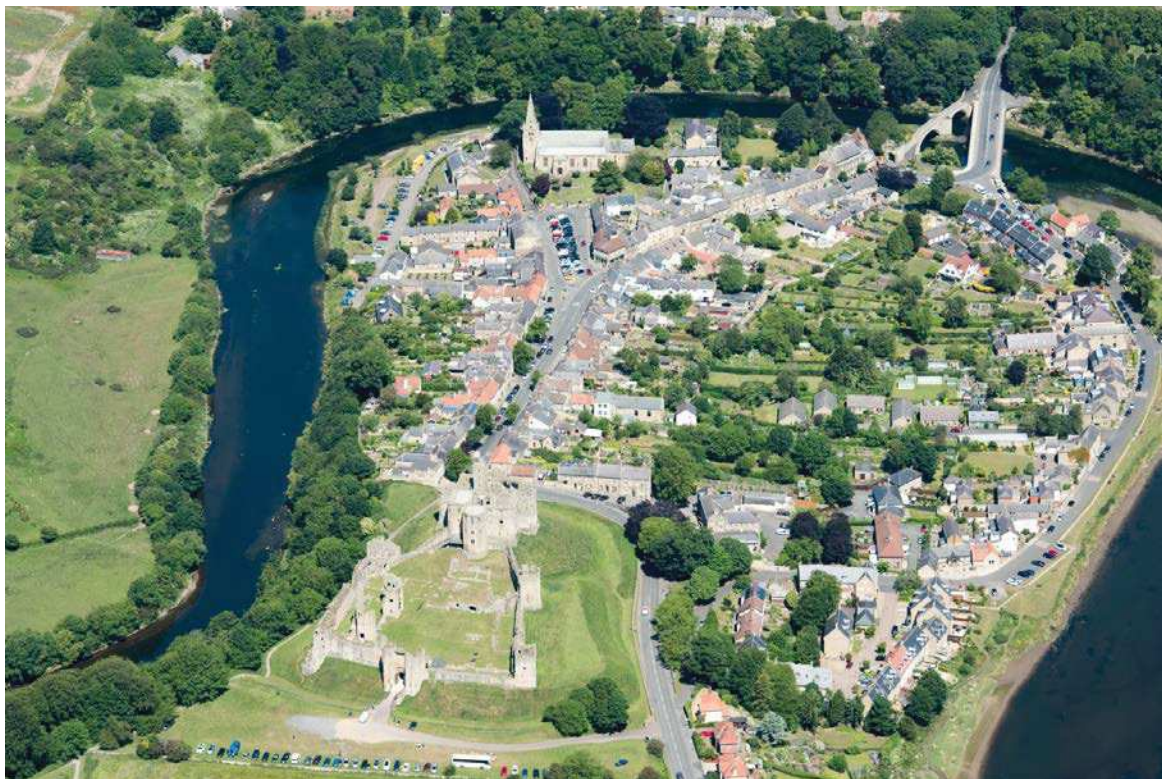
Figure 3. Oblique aerial view of Warkworth castle and village, looking north. The parish church and fortified bridge are visible at the top of the image. © Historic England Archive.

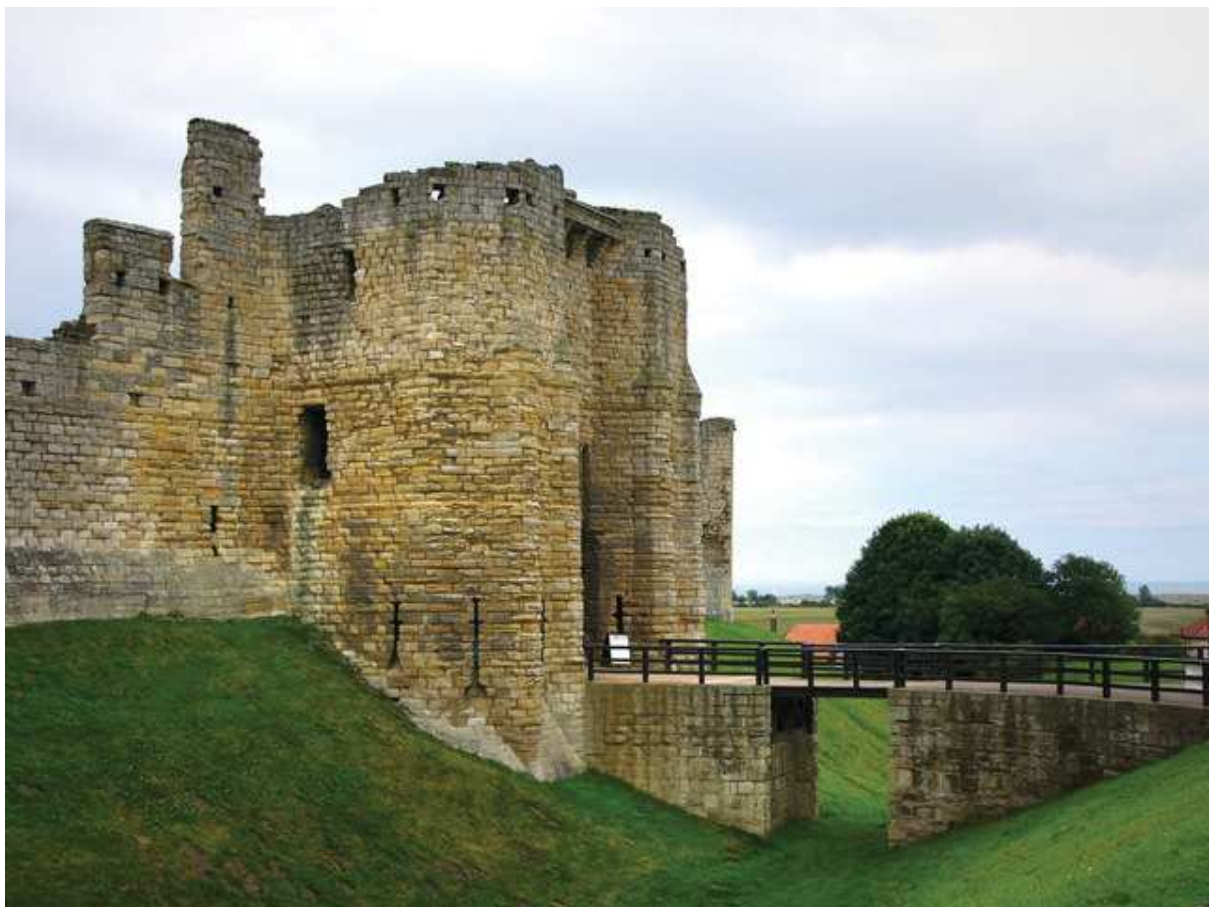
Figure 5. Gatehouse of Warkworth Castle, looking east. Chris Gunns / Warkworth Castle, entrance / CC BY-SA 2.0.

primary, formal entrance in the enclosure (see Figure 5). Polygonal towers with angular buttresses project into the fronting ditch on deep foundations, and these flank a passageway with pointed vaulting, punctuated by a portcullis slot and protected on its southern extent by checks for two doors opening outwards. Long arrowslits with cross slits and splayed triangular feet, nestled between the external buttresses, give light to side-chambers either side of the passage, which in the later 16th century served as a porter's lodge and prison respectively. Above the passageway and side-chambers was a chamber which in the 16th century pertained to the earl; it may have operated in many different capacities prior to this, but was feasibly a high-status space of sorts throughout. The next level above may have hosted a fighting platform or timber hoarding of c.1400, supported by a series of stone brackets and joist holes along the upper levels below the present line of the wall-head on the external, southern face of the gatehouse.

The gatehouse was originally flanked on either side by stone curtain walls, which survive fragmentarily on the west side of the structure (see Figure 5), perhaps a later rebuild), and appears to have been demolished and rebuilt on its eastern half. The south-west corner of the curtain wall is marked by the D-shaped, polygonally-sided Carrickfergus Tower, so-named for the association of a branch of the Lacy family (with whom the Percys of Warkworth were closely associated) who possessed the castle of that name in Ulster. Two upper floors within the Tower had latrines and fireplaces, marking them as apartments, while the ground-floor basement, lit by deep arrowslits of similar character to those in the gatehouse, had no facilities, but was accessed via the ground-floor basement of the adjacent

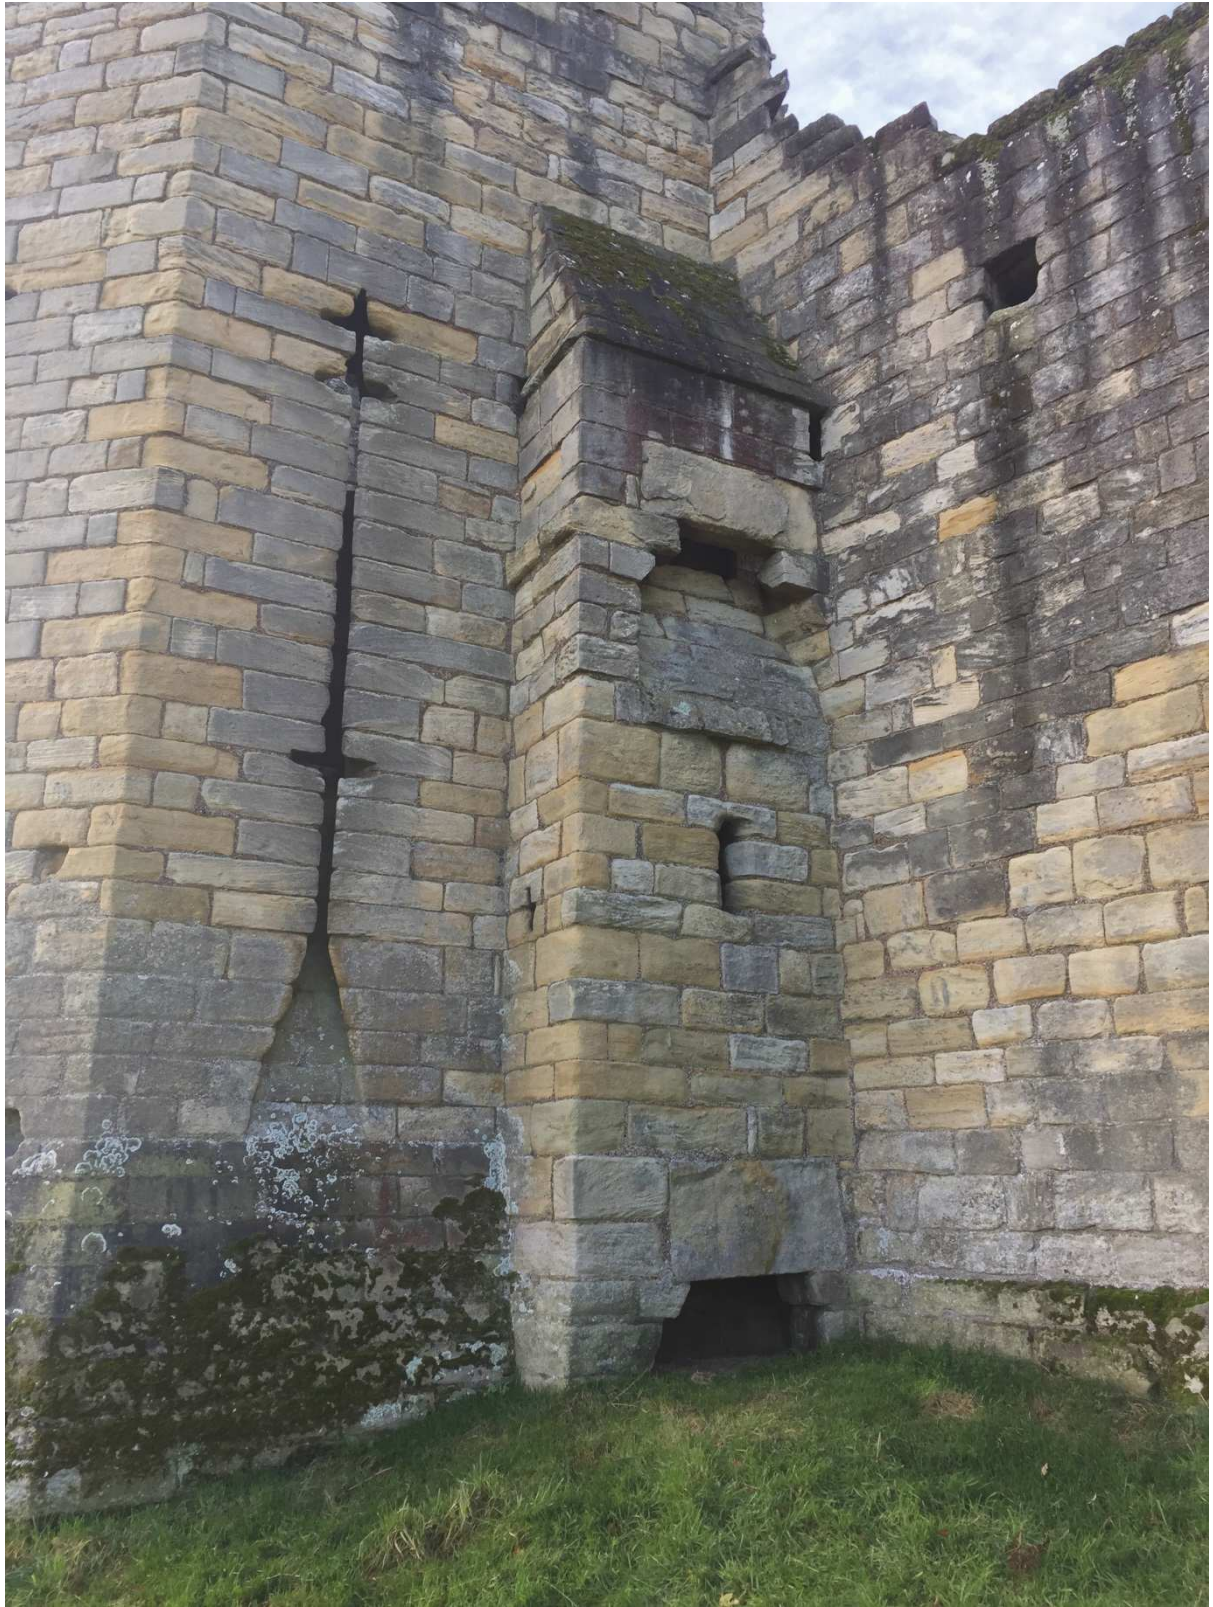
Figure 6. Photograph of latrine chambers adjacent to the Grey Mare's Tail Tower, looking south-west.
© William Wyeth

A pair of latrines was constructed at wall-head level on the curtain wall to the south of the Grey Mare's Tail Tower, a massive buttress (housing chutes) carrying eastwards to support this new feature. South of these new facilities, feasibly only accessed by a parapet walk either via the Grey Mare's Tail Tower, a lost staircase within the bailey, or a precursor to Montagu Tower to the south, the curtain wall was rebuilt. This may have been necessitated by the insertion of a precursor to the later postern here, or by the rebuilding of the corner tower located here. Additionally, a small range of buildings dating to this phase of construction was built on the interior face of the south curtain wall, to the east of the gatehouse. Very little is known about them, except the fine mouldings of door jambs to the easterly of the buildings.

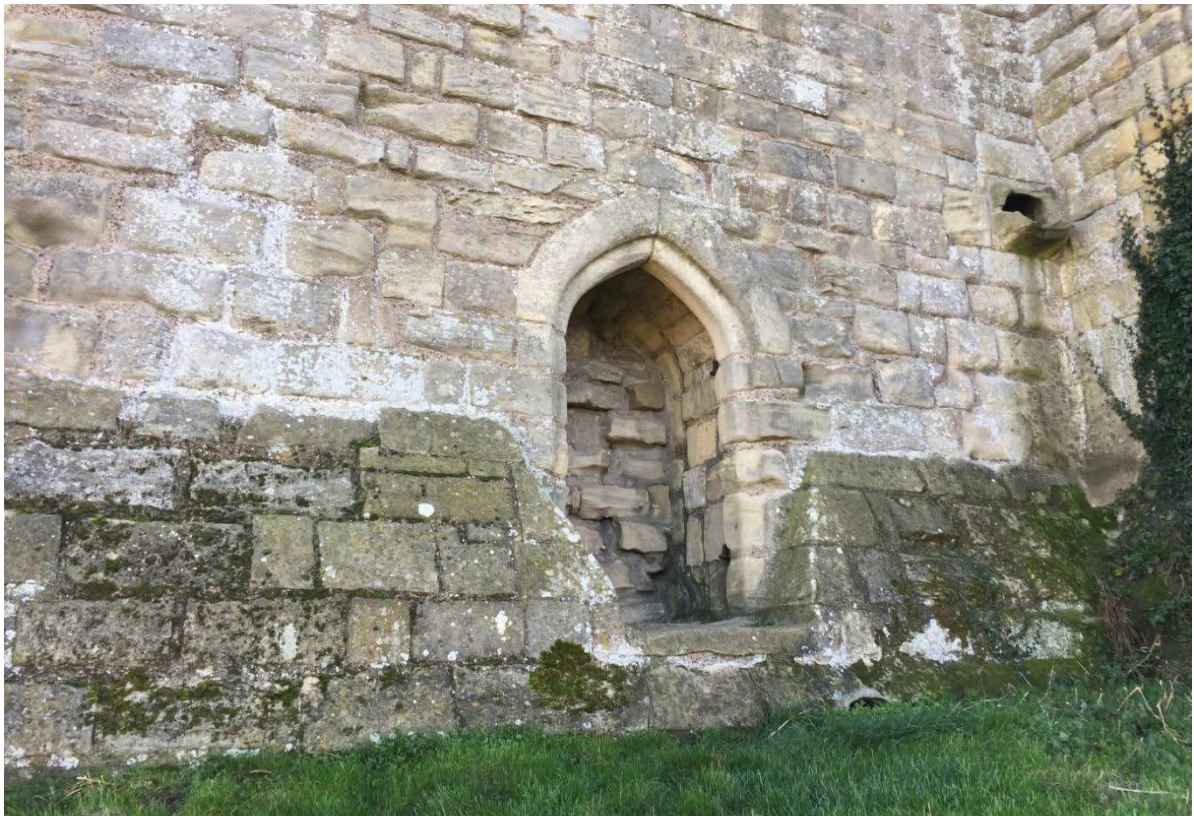
Figure 9. Photograph of the postern within the Great Tower, giving access to the motte-top area outside the embrace of the curtain walls, in the north-west of the ground floor. Note the door threshold is seamless with the floor level of the passage inside, for ease of use. © William Wyeth

A possible stone-lined drain was identified (feature **13**) during the motte-top portion of the survey. This feature may be associated with the postern in the Great Tower granting access from the motte-top into a chamber associated with food storage, or the openings of drains from the tower emptying here (Figure 9). The postern is presently blocked up, an undated change, but perhaps undertaken in the 19th century, when a portal linking the chapel and great chamber within the Great Tower was also blocked. The drain may thus relate to the medieval use of the postern, clearly devoted to servicing the tower rather than any defensive consideration; or, the drain may be a post-medieval insertion.

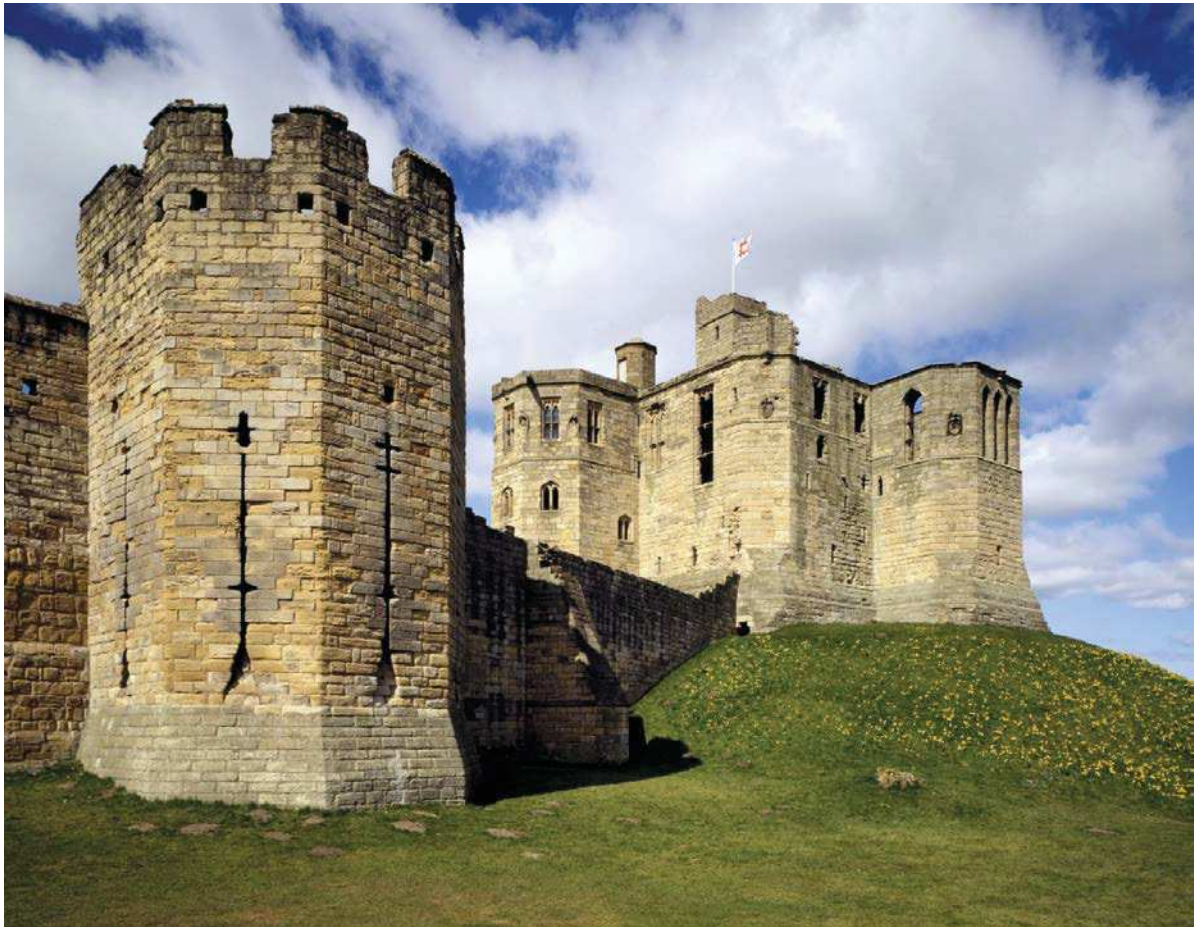
Figure 10. Photograph of Grey Mare's Tail Tower, Warkworth Castle, looking north-west. © Historic England Archive.

eastern wall portal mentioned above, and its northward trajectory from there looks to respect the projection of the Grey Mare's Tail tower (see Figure 8, Figure 10).

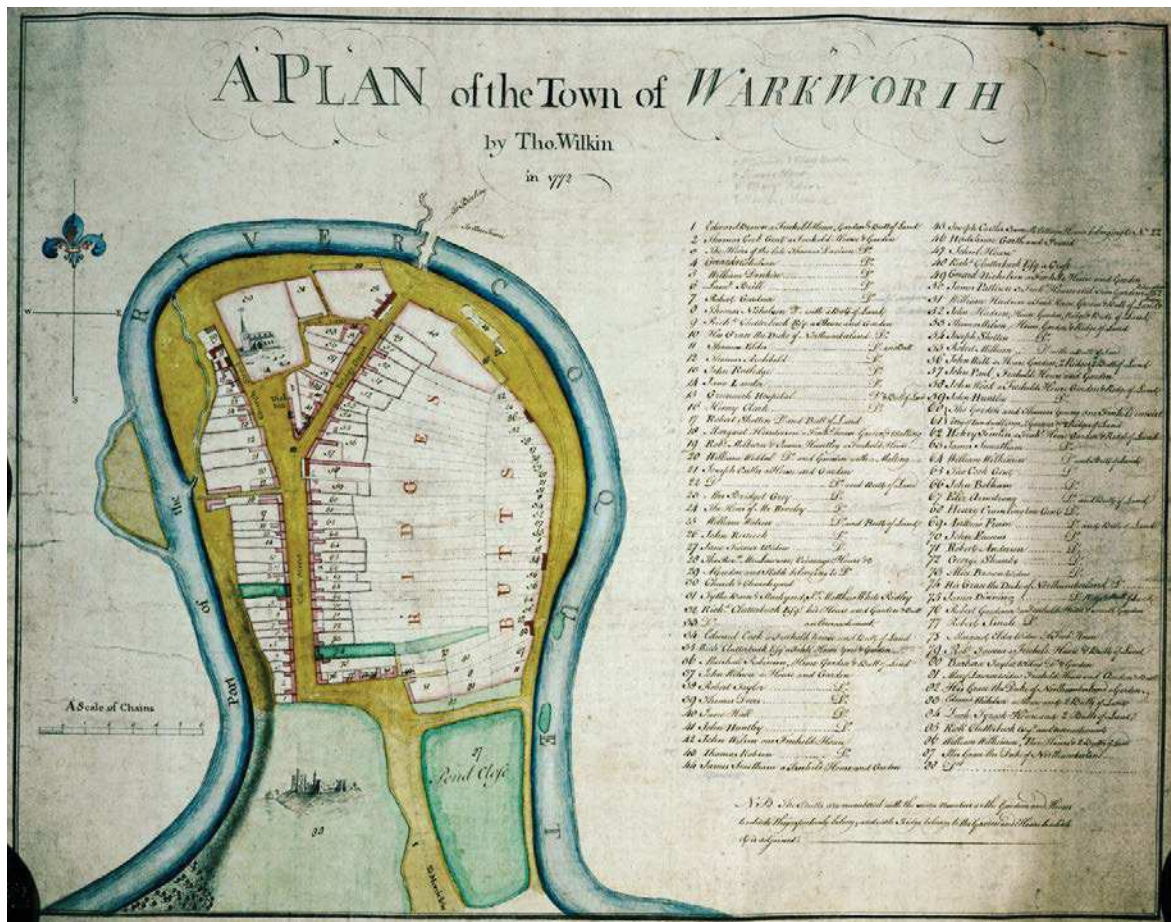
Figure 11. Plan of Warkworth by Thomas Wilkin (1772). 'Pond Close' is visible to the east of the castle location. © Collection of the Duke of Northumberland, Sy: B.III.2.a.

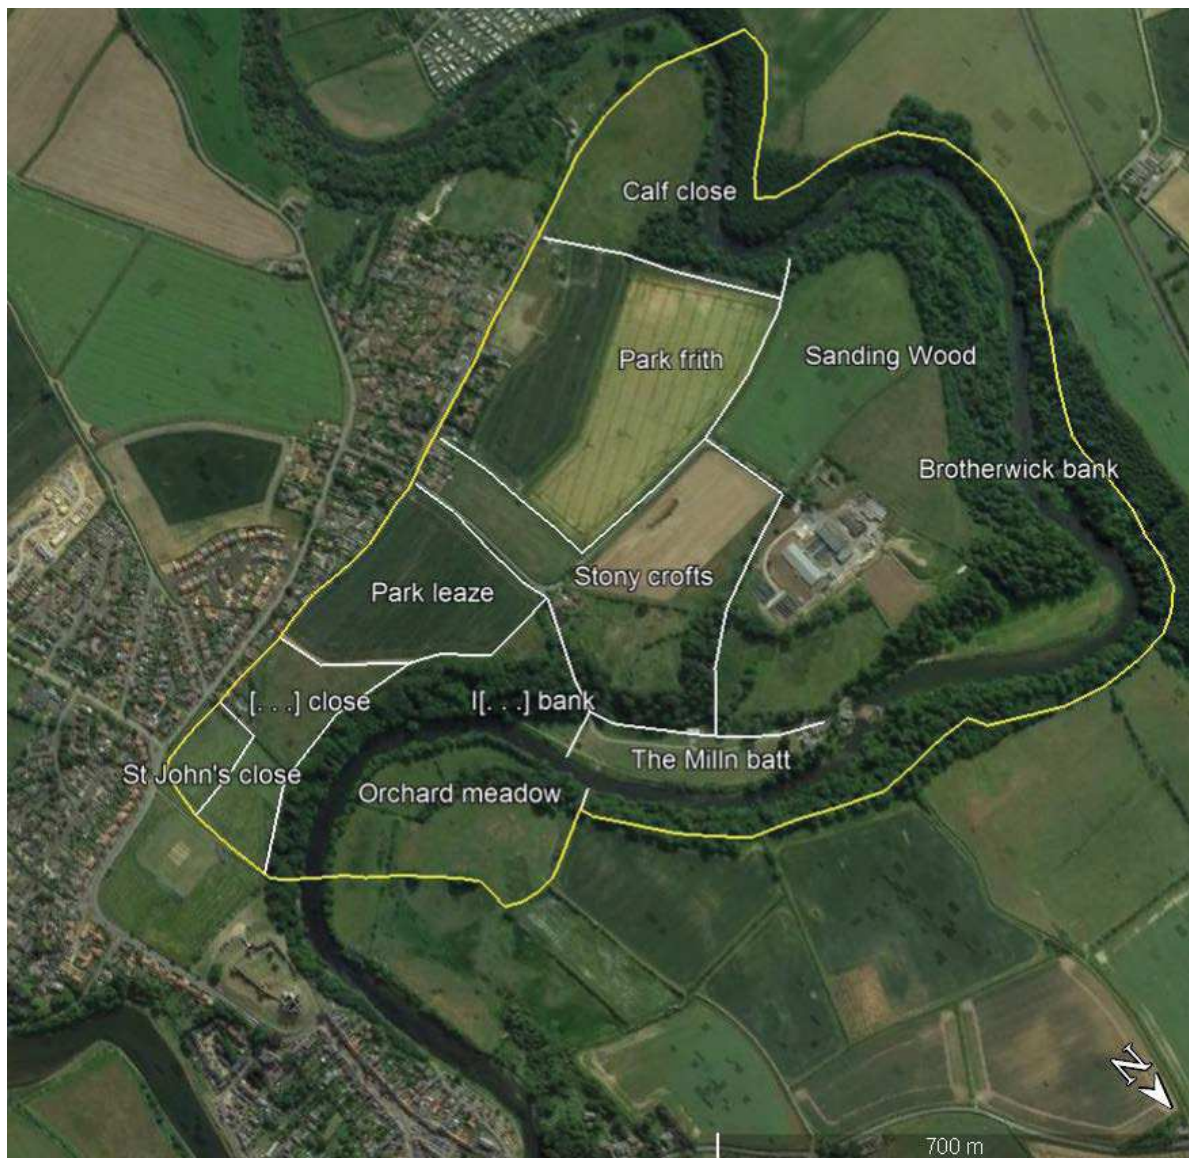
Figure 15. Sketch of selected approximate field boundaries and field names projected onto modern satellite imagery. Satellite imagery © Google Earth, annotation William Wyeth.

Figure 15). The shape of fields leading to this gate, somewhat funnel-like in profile, may hint that this was a point in the park pale in which deer were encouraged to enter the park bounds, along the small but deep stream ravines which enter the Coquet along the north bank either within or close to the park boundary. A second possible park gate is attested in the 1620x3 estate map on the north side of the Coquet close to the position of the Hermitage. Two field names noted by Beckensall, *Yateside Lonnin* and *Lain Close*, may demonstrate an entry here, though none is depicted in the vicinity.⁵² This gate may be that mentioned in a 1567 description of the park: “the mill-yate”. The context of this reference, being preceded by the area called “Houwnden-mouth” and followed by “th’ east corner of the payle at th’ end of th’ Orcharde medowe [...]” places this gate on the north bank of the Coquet.⁵³ The reference to the mill, whose site is quite close to these known named features, suggests it may be the *yate* implied by the 1620x3 field-name. The final gate is both depicted as a tall round-headed portal on the 1620x3 estate map (see Figure 13-Figure 15) and is likely referenced in the 1567 description of the extent of the park at Warkworth, which is noted by Hodgson: “viz from Cradyfargus towre overe to the park yate ys [blank] from thence to th’ east noyke or corner of the close called Sanct John’s close [...]”⁵⁴

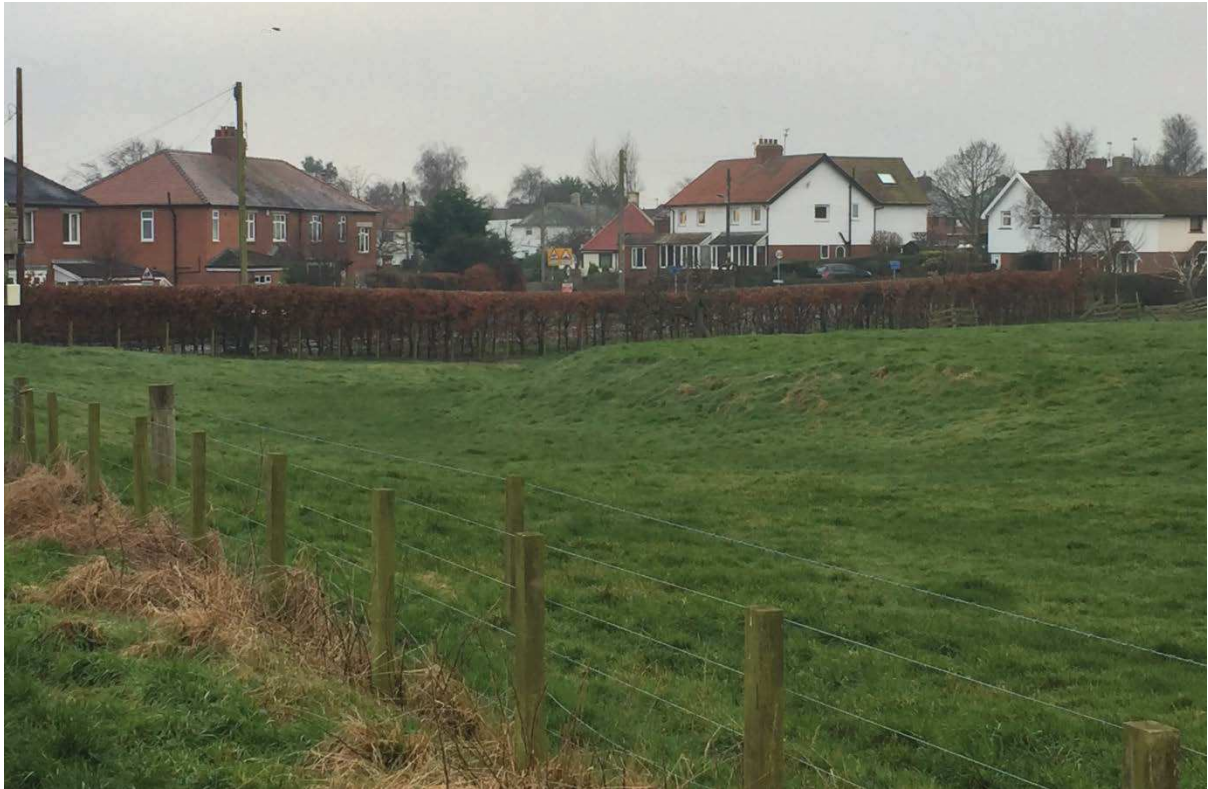
Figure 16. Photograph of south-easternmost corner of park (within historic St John's Close), from the modern footpath linking Morwick road (the southern boundary of the 1620x3 park) and Warkworth Castle car park, looking south-west. The raised ground on the right in the middle distance marks the angle of the bank, the slightly raised ground on the left (by the back fence line) may represent the outer pale bank. © William Wyeth.

Presently, the field of St John's Close contains open grassland, intermittently used for pasture and temporary parking during the Warkworth Fair (Figure 19). The northern two-thirds of the adjacent field which was also subject to survey contains a broad east-west aligned ridge and furrow (Figure 20). Areas of suspected earthworks, comprised a bank and areas of depression, are also noted in the south and east of the field (see Figure 16-Figure 18).

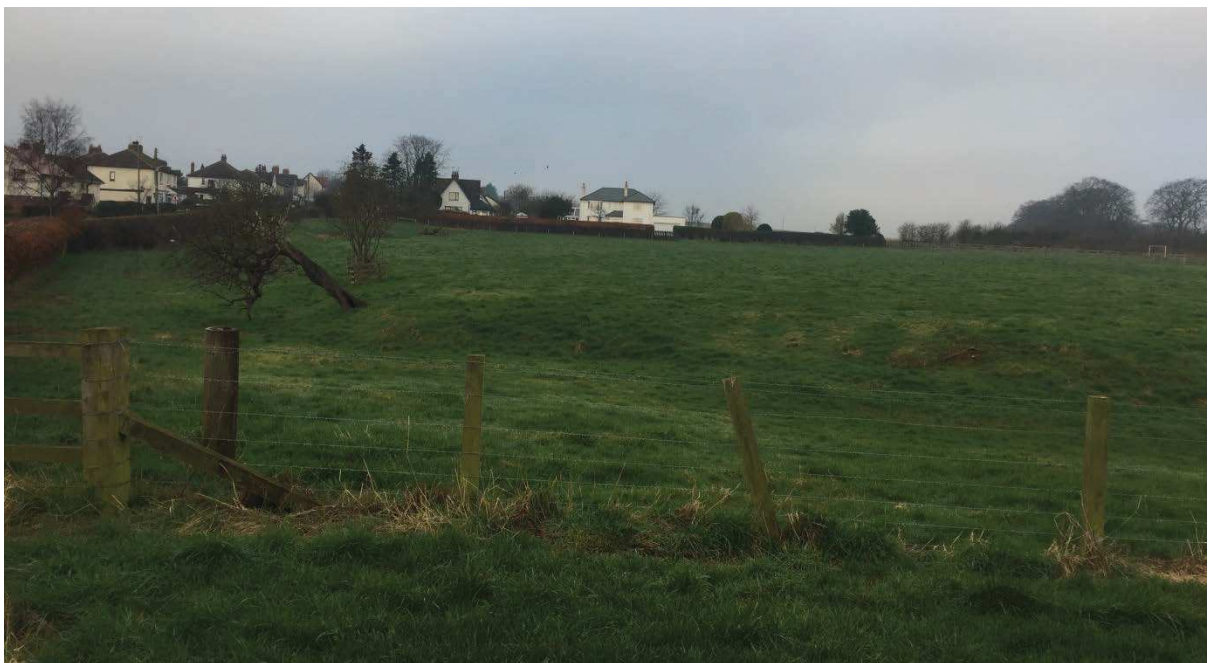
Figure 17. Photograph of south-easternmost corner of park (within historic St John's Close), from the modern footpath linking Morwick road and Warkworth Castle, looking east. The weather-beaten cherry tree on the left in the middle distance marks part of the suspected park pale earthworks. The outer bank may be marked by the raised ground in the foreground. © William Wyeth.

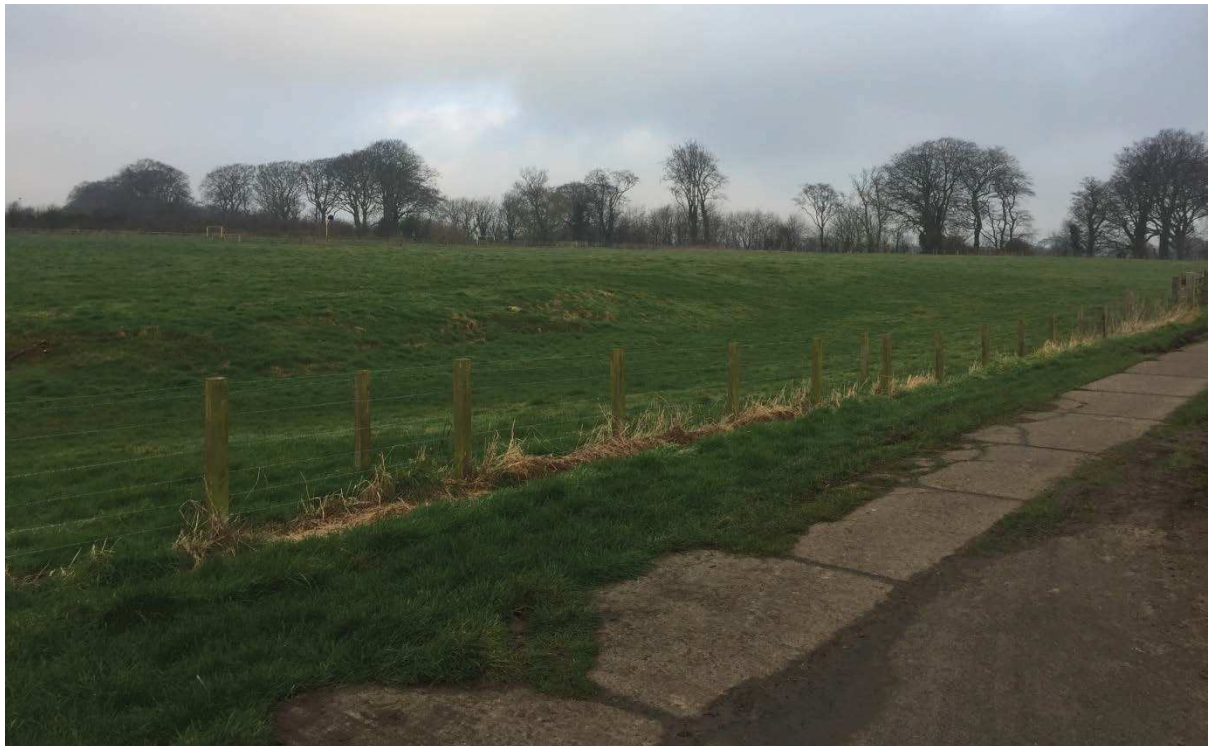
Figure 18. Photograph of south-easternmost corner of park (within historic St John's Close), from the modern footpath linking Morwick road and Warkworth Castle, looking north-west. The ditch running northwards is visible in the middle distance, with an inner bank surviving too. The modern pathway sits in a raised causeway leading towards the castle which may partly overlie the outer park pale bank. © William Wyeth

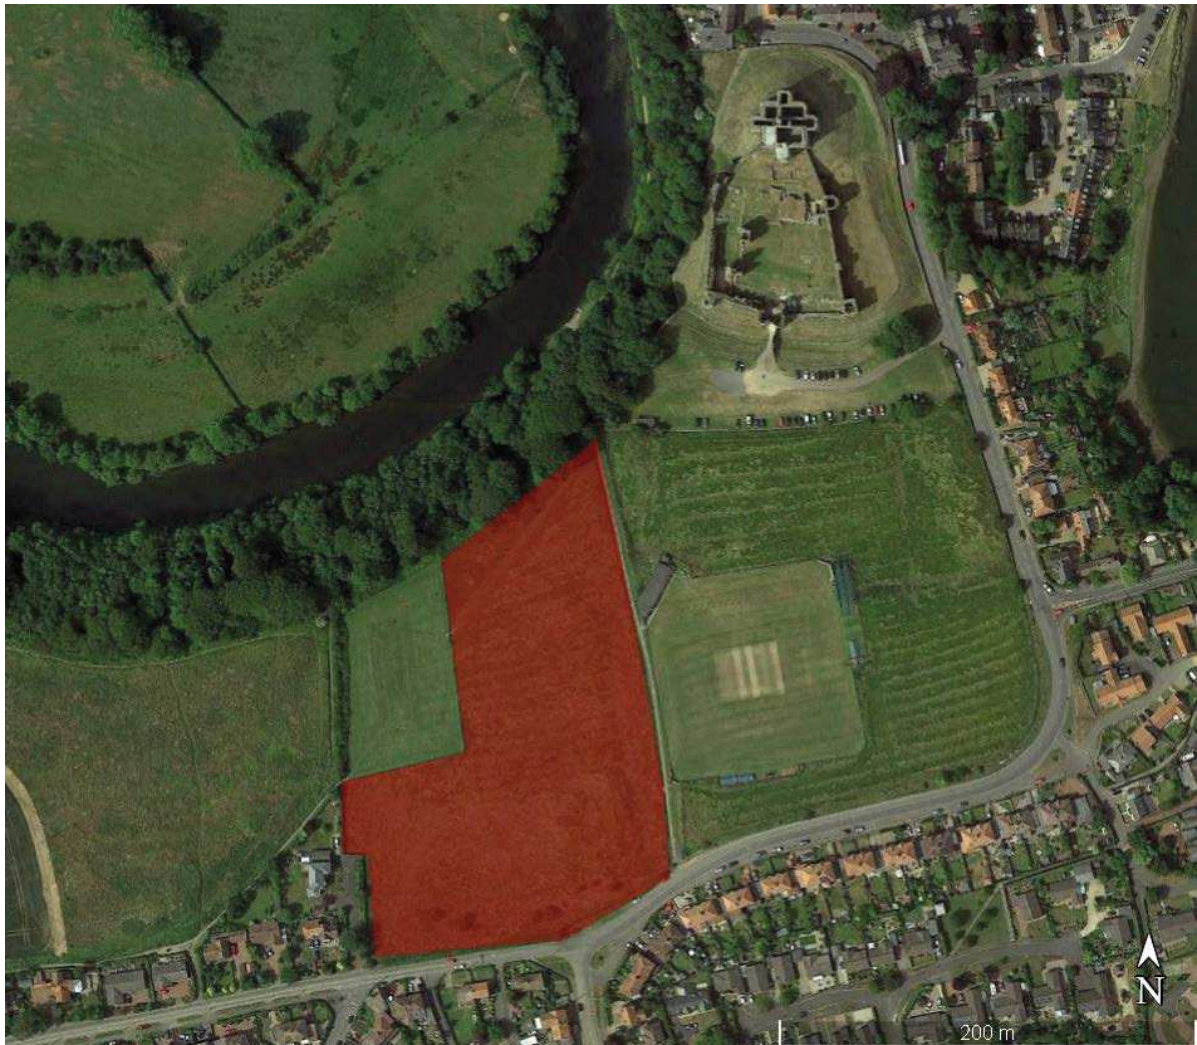
Figure 19. Satellite image of area to the south of Warkworth Castle, with the area of survey marked in red. © Google Earth.

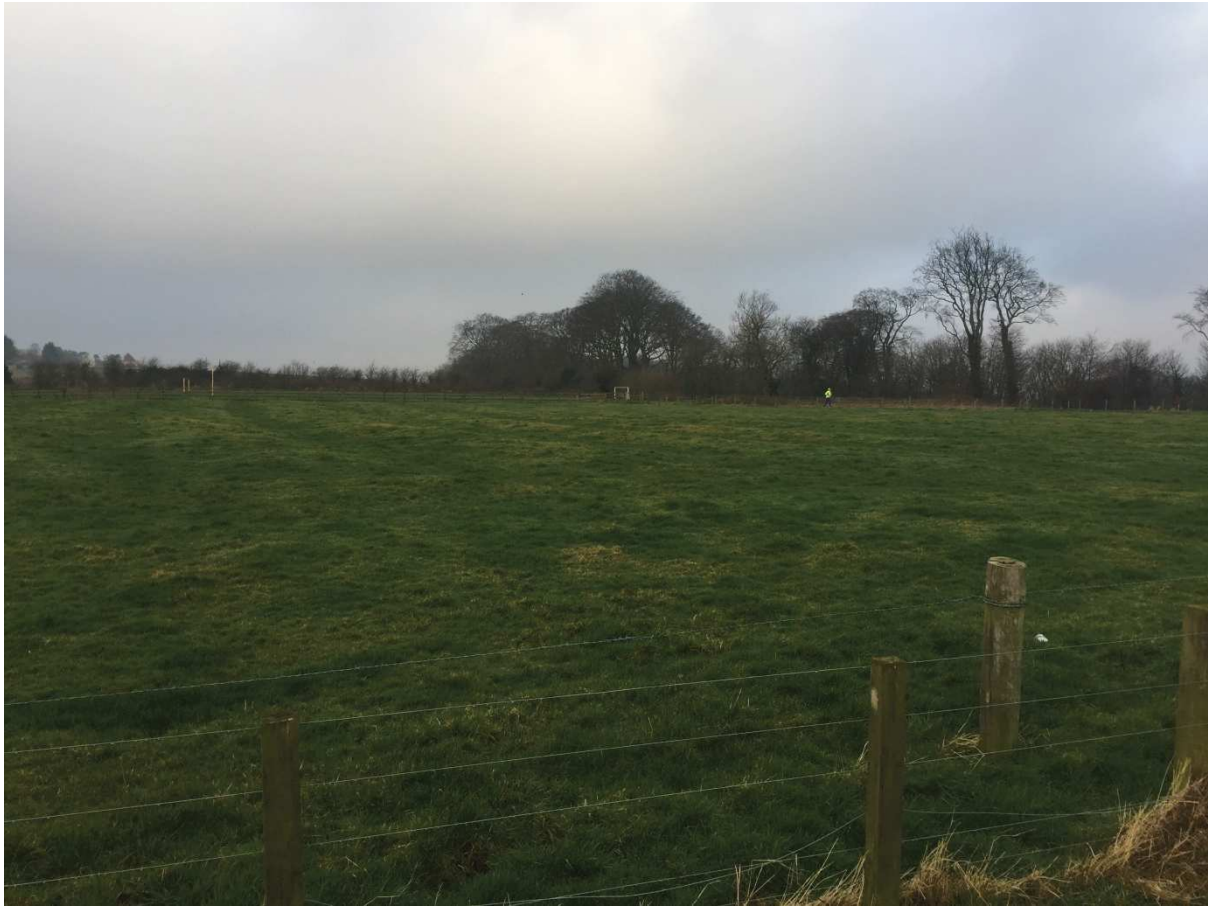
Figure 20. Photograph of St John's Close, ridge-and-furrow earthworks carrying into distance. The ridges feature as light raised banks, the furrows as darker parallel features. © William Wyeth

Broad parallel bands of alternate positive and negative magnetic anomalies have been detected across the northern part of the survey area; these anomalies correspond to a similar pattern of alternate high and low resistance anomalies. The anomalies reflect the existing ridge and furrow earthworks (**1**); in this instance the positive magnetic/high resistance anomalies reflect the upstanding ridges (more topsoil/less moisture), while the negative magnetic/low resistance anomalies indicate the furrows (less topsoil/more moisture) (see also Figure 20). These features are also evident as weak reflections in the upper part of the GPR data. The ridge and furrow is aligned broadly-east-west, with furrows typically spaced at 6-7m intervals. There is no headland evident at the eastern end of the ridge and furrow, and the earthworks appear to have been truncated by the broad linear cut along the eastern side of the field. The date of the ridge and furrow is not known, but it may be noteworthy that its southern extent appears to respect the boundary with St John's Close to the south (no longer extant as a standing feature), which is depicted as a distinct enclosure in the 1839 tithe map. The slightly curved, broad pattern of the ridge-and-furrow is typical of earlier medieval typologies of the earthwork, when teams of oxen were used to draw the plough.⁶⁵

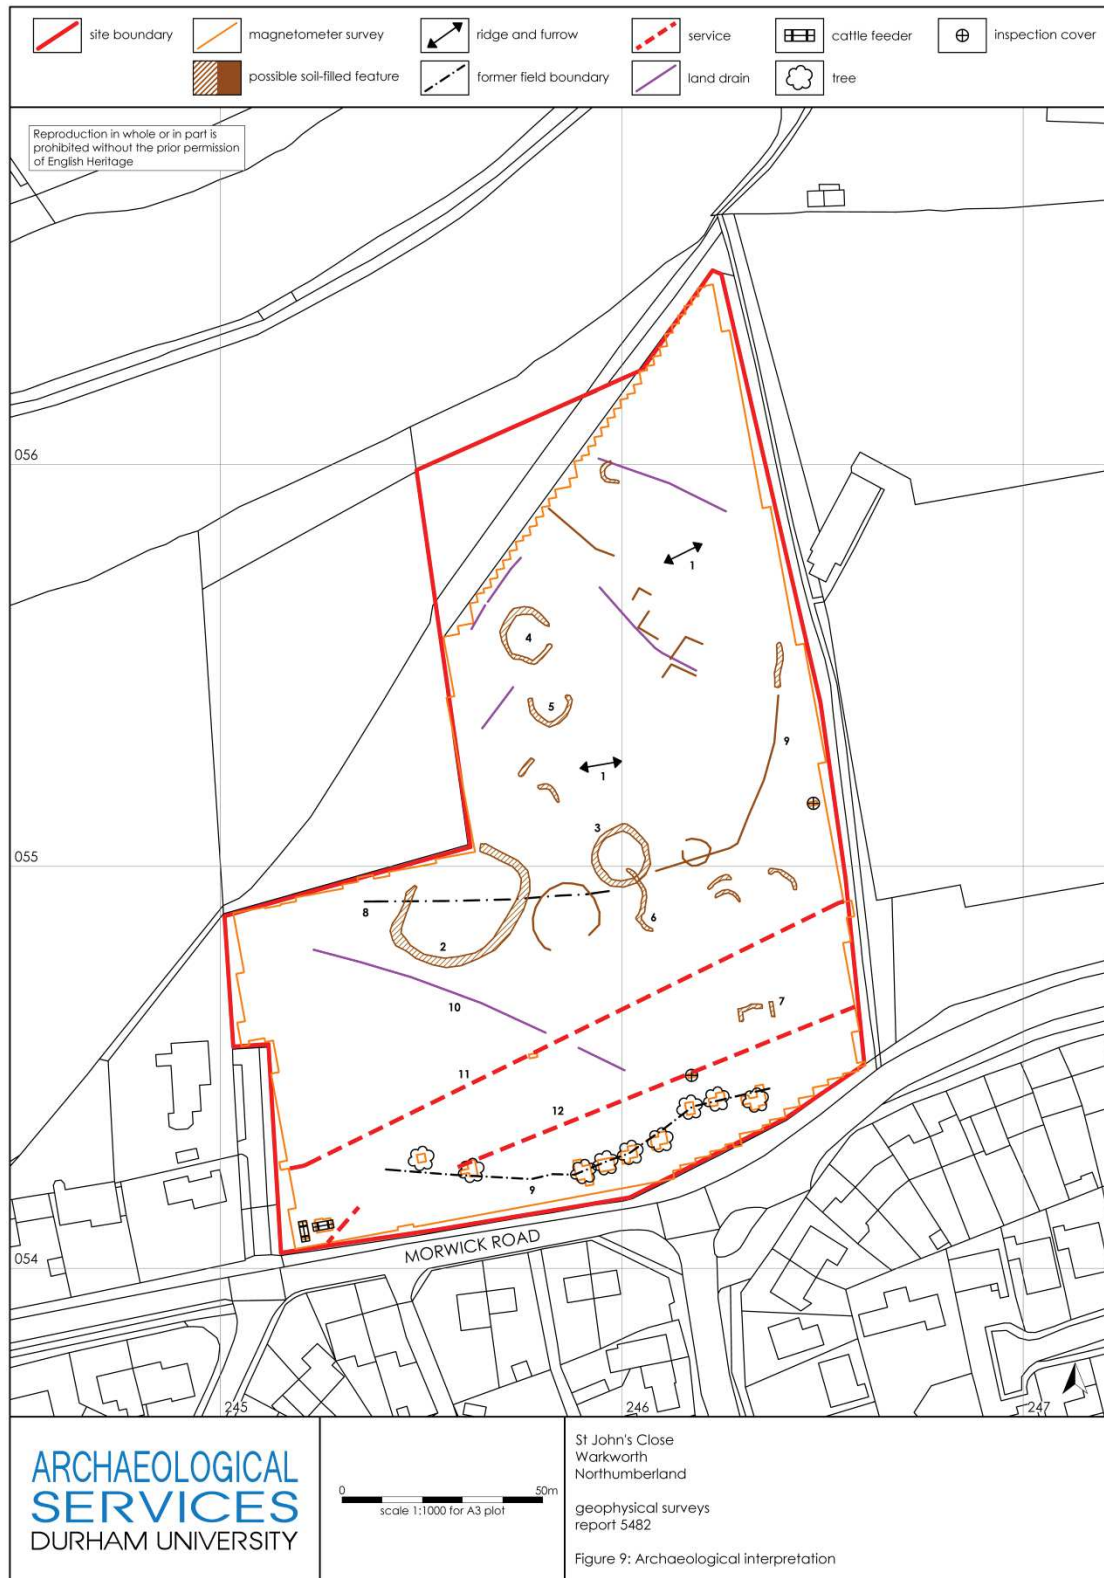
Figure 21. Survey plan of St John's close near Warkworth Castle detailing archaeological interpretation of geophysical surveys. Ordnance Survey © Crown copyright

weak, magnetic and resistance, anomalies can be discerned within the enclosure, they cannot be confidently interpreted as the remains of internal features.

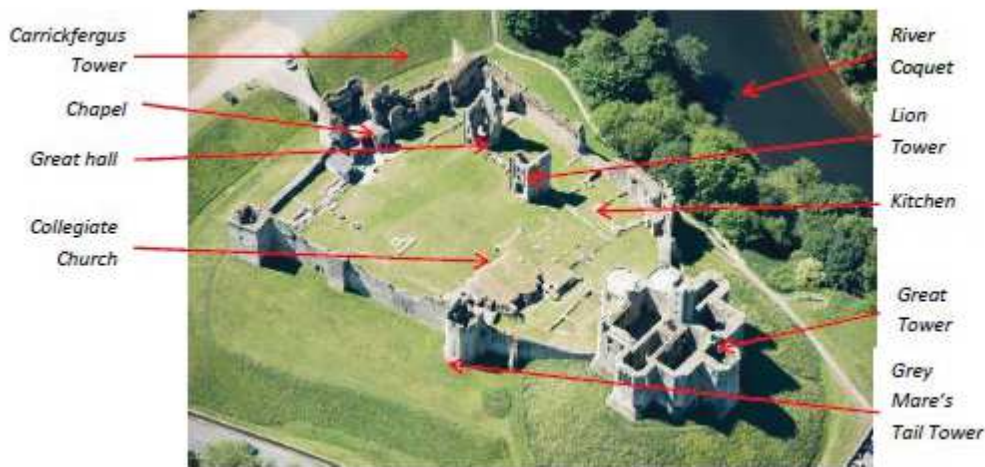
Figure 1: A selection of features within the castle. Oblique aerial photograph of castle looking South-West. © Historic England (Emma Trevarthen).
