Archaeological Survey  
Ballintober Castle  
Ballintober, Co. Roscommon  
Ireland

RO027-048002-

Niall Brady

Castle Studies Trust  
2014 Grant award

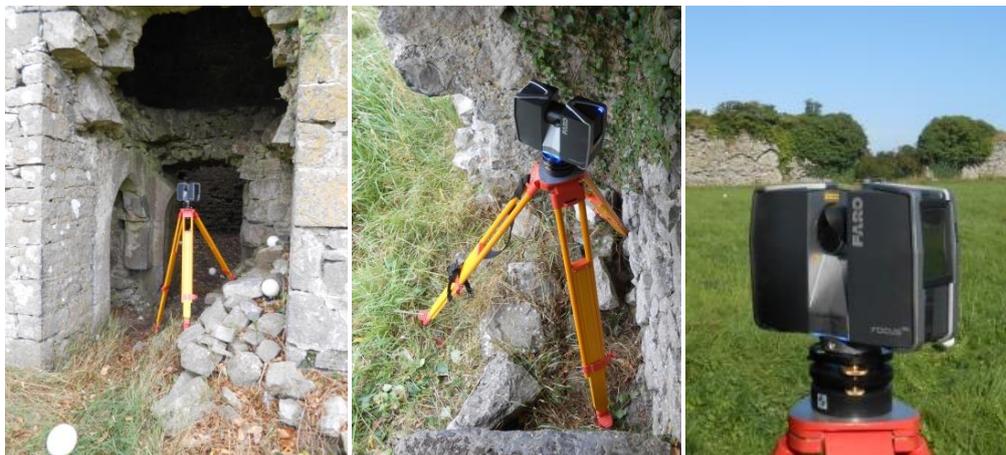
Figure 1 – Faro Focus 120 laser scanner at Ballintober

Distance	accuracy up to $\pm 2$ mm.
Range	from 0.6m up to 120m.
Measurement rate	up to 976,000 points/sec.
Measurement values	Intensity & RGB. Integrated colour camera.
Georeferencing	Using RTK GPS with VRSnow corrections

The laser scan was undertaken using a Faro Focus 120 phase-based laser scanner and a spherical target system for registration. Images of the scanner in action, and the specification of the scanner are detailed below.

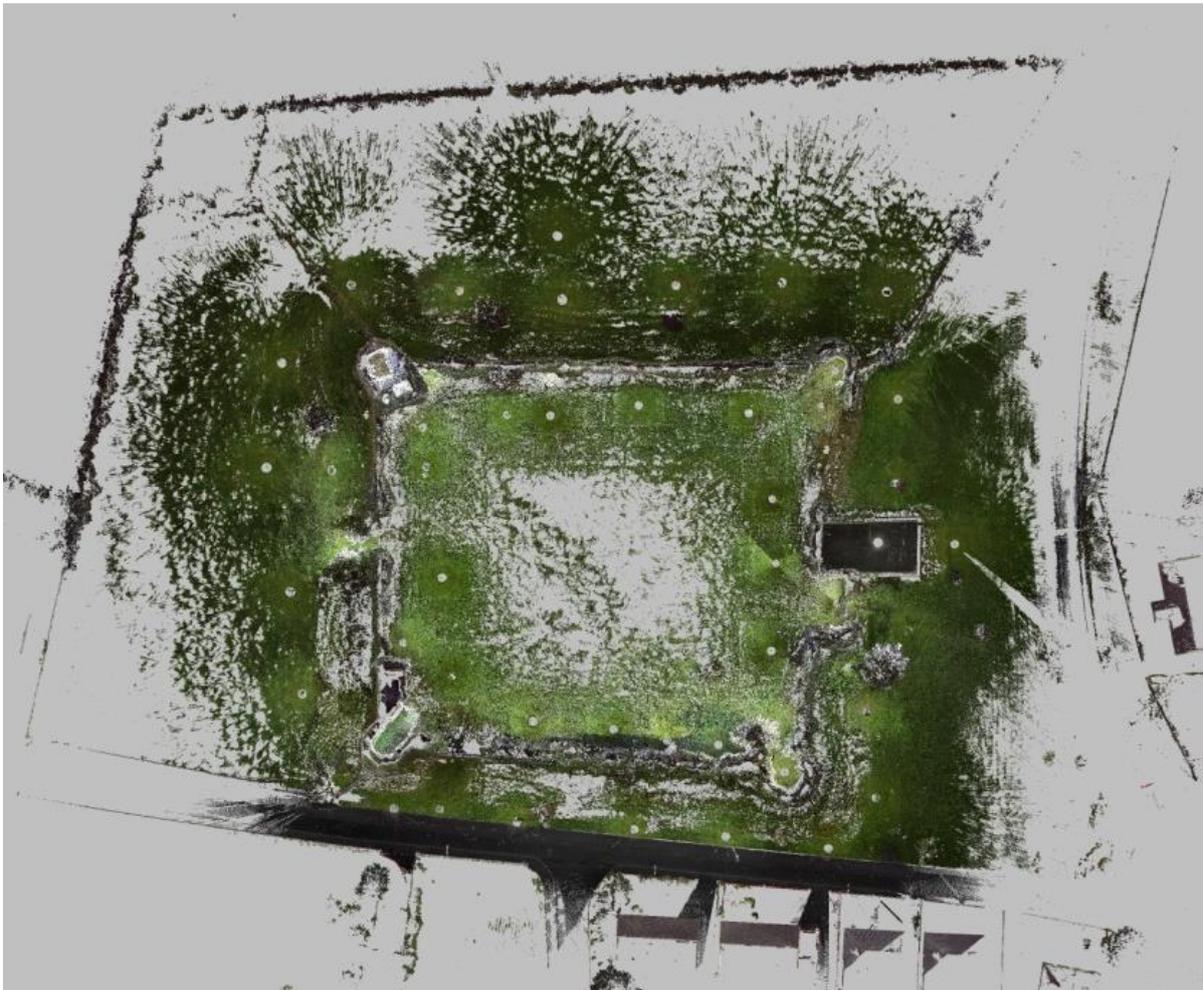
Figure 3 – Plan view of the pointcloud data for the complete Balintobber Castle survey

Laser scans were undertaken over a three-day period in August 2014 from a total of 64 individual stations, generating a final project pointcloud with approximately 800 million points.

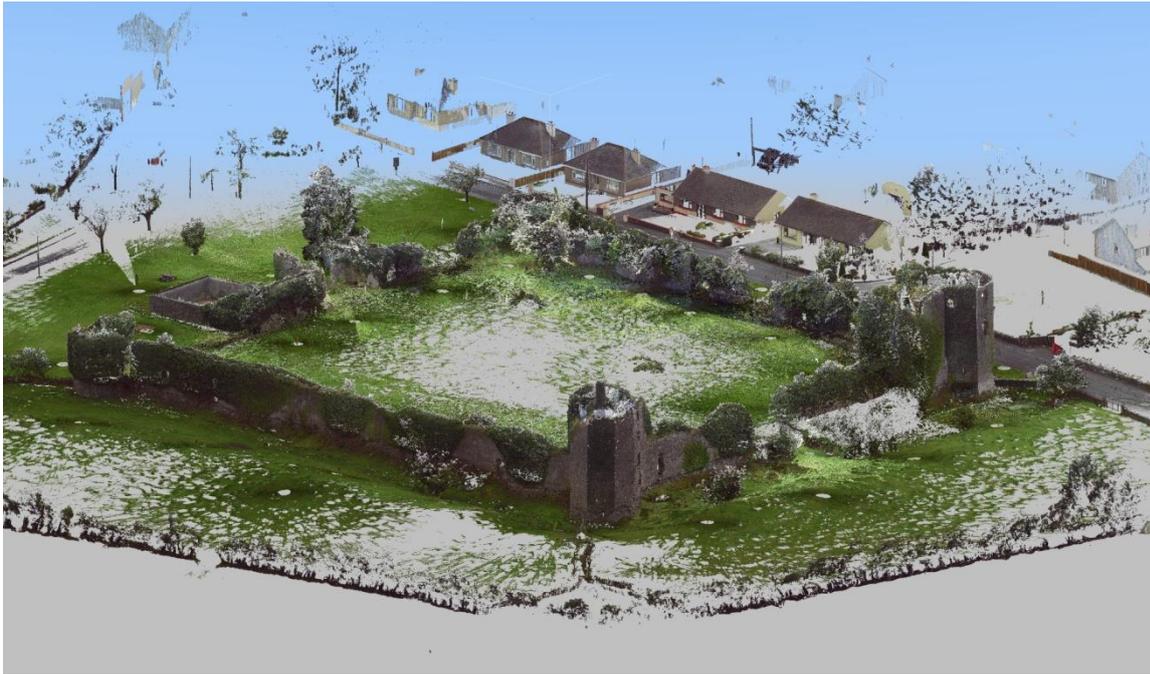
Figure 3– Isometric view (from the Northwest) of the pointcloud data for the Ballintober Castle survey

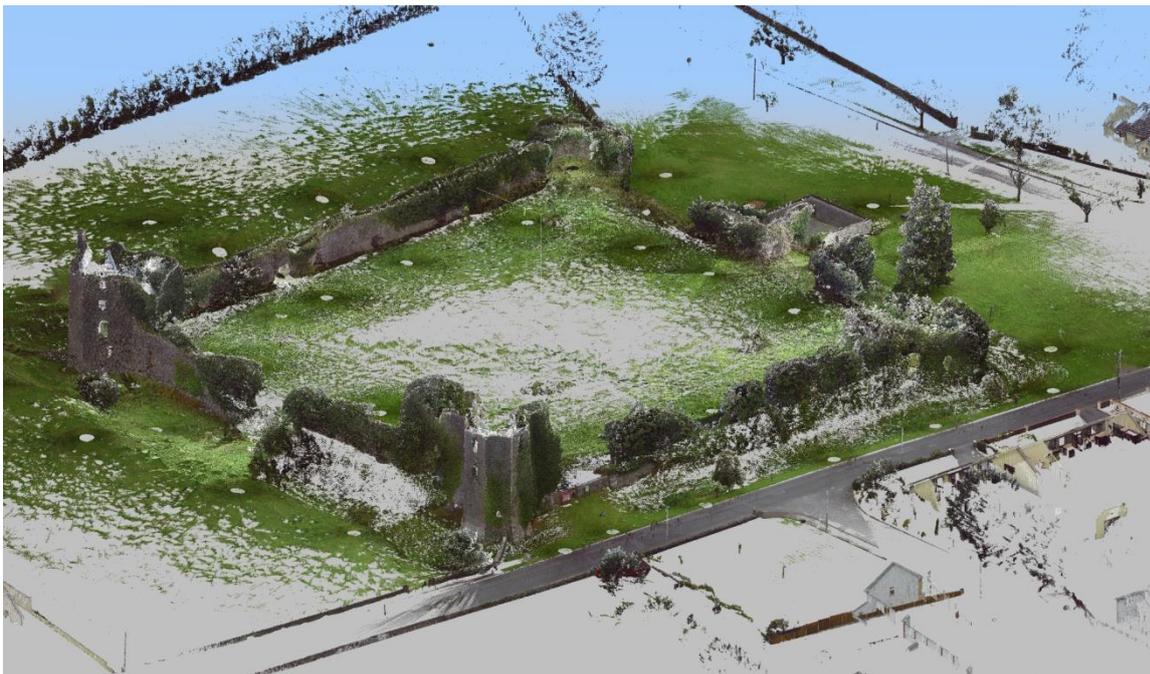
Figure 4 – Isometric view (from the Southwest) of the pointcloud data for the Ballintober Castle survey

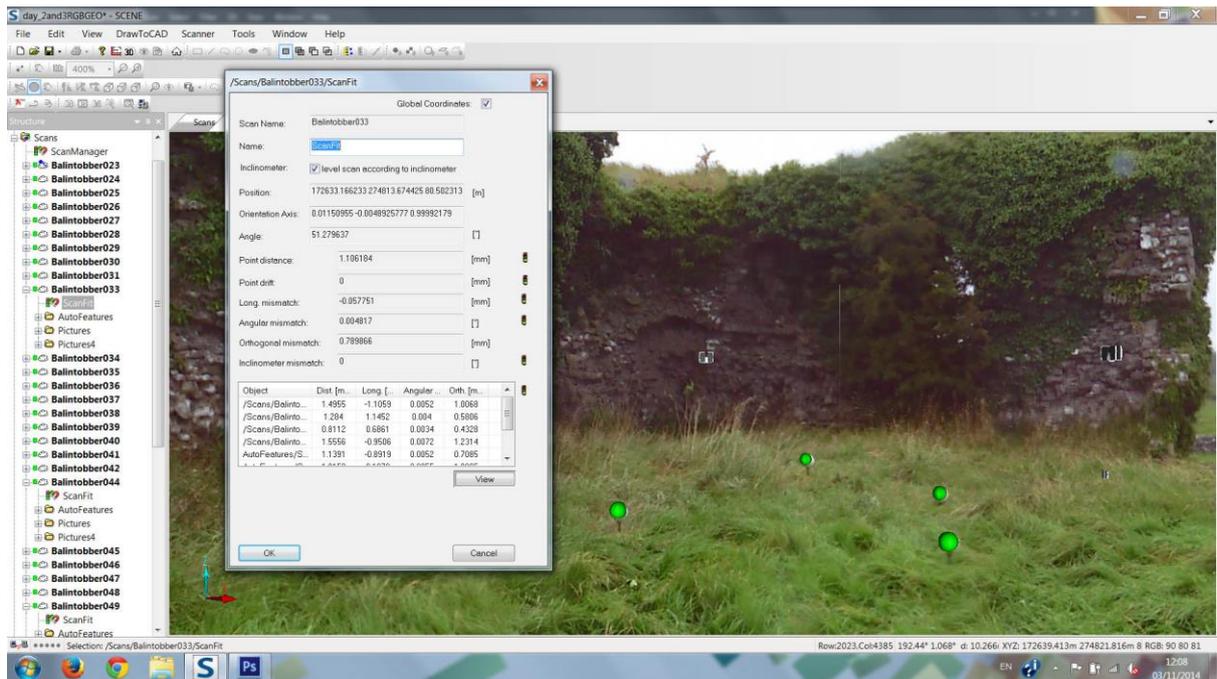
Figure 5 – ScanFit report from Faro Scene software.

For this survey the residuals were excellent and no high residuals encountered. The consequence of this is a reduced level of ‘noise’ in the final pointcloud – good clean data.

Survey data is processed in Faro Scene, registering scans using the common sphere targets. Quality control is assured by examining in detail each scan fit, and if the residuals are above a pre-defined threshold, in this case 3mm, then action is taken. Figure 5 shows a typical Scanfit report, indicating a fit well within tolerance.

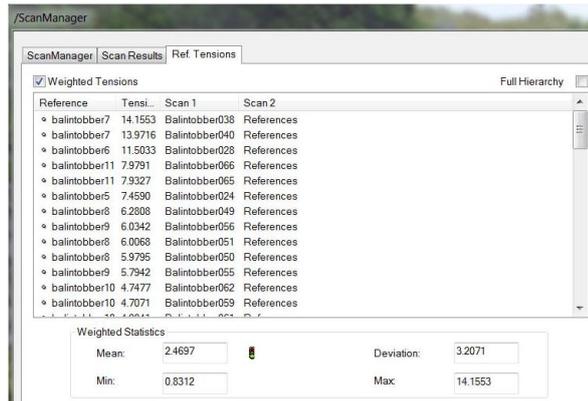
2. The georeferencing quality. Figure 7 shows that the maximum error from the GPS coordinate georeferencing is of an order well within the acceptable tolerance of the VRS Now correction service.

Figure 7 – Reference Tensions results of the Place Scan Auto function from Faro Scene processing

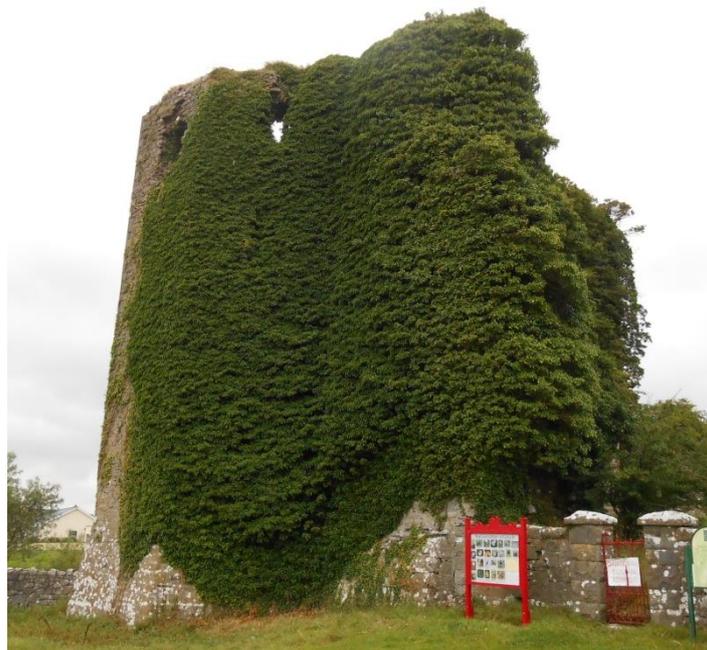
Laser scanners can only scan the parts of the building visible to the scanner from its set-up location and this inevitably leads to parts of buildings missing from the pointcloud. The surveyor's experience will be used to limit these data gaps, but in the case of Ballintober the level of thick vegetation growth presented a serious problem. The vegetation was removed at the lower levels to reveal as much of the surface stone as possible, but the higher towers remained obscured from the scans. It is hoped that some returns will have penetrated the vegetation, but it is doubtful as to how effectively the shape and detail would be recorded.

Figure 7 – Overgrown vegetation of the exterior of the Southwest tower

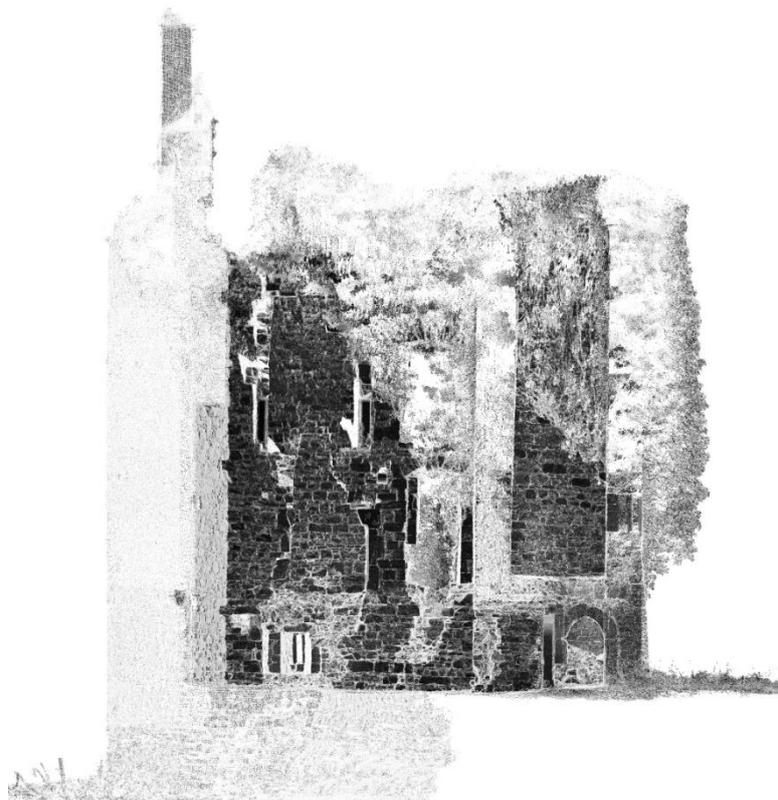
Figure 10 – Cross section through the Northwest tower (looking Southwest) displaying the level of architectural detail recorded in the pointcloud.

The deliverables provide the basis for further investigation, enabling the extraction of scaled dimensions, formal views such as elevations and plans, and user-defined cross sections.
